Overview

The purpose of this memo is to inform you that XC18V00 devices with the topmark "ART" are sensitive to noise when operated outside of the data sheet specification.

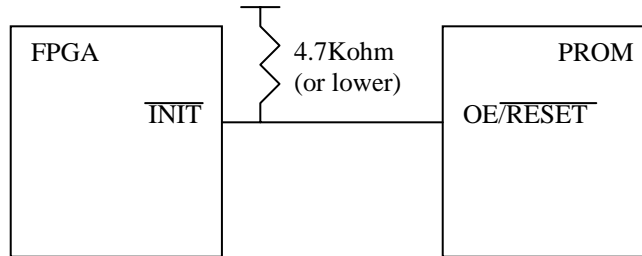
Figure 1 (Recommended Resistor Value)

1. As specified in the data sheet, an external resistor of 4.7-Kohm (or lower) is required to quickly pull up the FPGA INIT and PROM OE/RESET# signal line. If the FPGA INIT and PROM OE/RESET# signal line rises too slowly, then system noise might corrupt the PROM's internal address counters, thus keeping the FPGA from configuring properly.
2. As specified in the FPGA data sheet, do not exceed 12-mA sink current on the FPGA DONE pin. Beware of LED driving circuits. Using DONE to drive the LED and the PROM CE# pin directly (un-buffered) exceeds this specification. This also affects the FPGA drive_done option.

1. Follow the data sheet to ensure that an external 4.7 Kohm (or lower) resistor is connected to the PROM's OE/RESET# pin and the FPGA's INIT pin. Ensure that the FPGA TICCK specification is met (500ns). This translates to a Trise and Tfall time of 500ns for the PROM's OE/RESET# signal.
