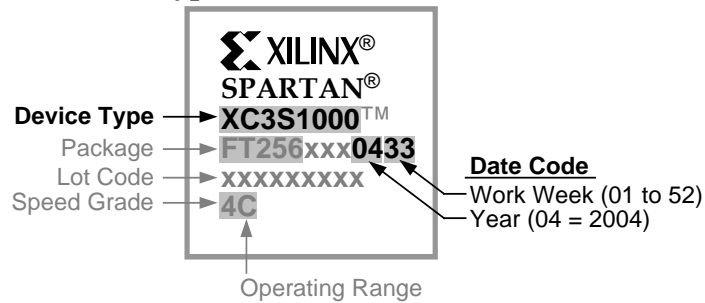
Figure 1: Example Spartan-3 Package Markings

| Date Codes: | Parts marked with date code “0433” or later (greater). See <a href="#">Figure 1</a> . |

[Figure 1](#) shows an example top marking for a Spartan-3 FPGA. The relevant fields to identify an affected device are highlighted and include the **Device Type** and the **Date Code**.

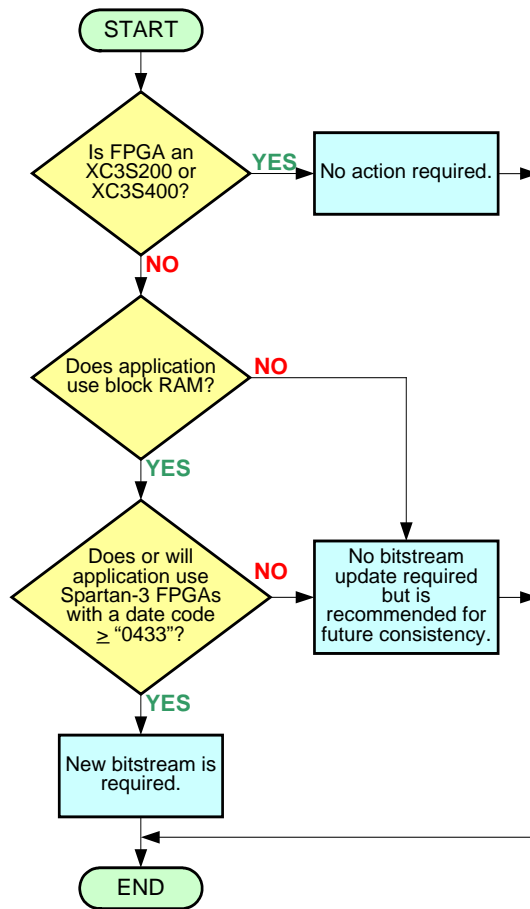
Figure 2: Spartan-3 Bitstream Update Decision Diagram.

The update, however, is not absolutely mandated for all applications. [Figure 2](#) diagrams the decision process on whether a bitstream update is required for a specific Spartan-3 FPGA. No update is required for XC3S200 or XC3S400 FPGAs. Similarly, if the FPGA application does not use block RAM, a bitstream update is not required but is recommended for future consistency. Likewise, if the FPGA is not an XC3S200 or XC3S400 but has a date code prior to—*i.e.*, less than—“0433”, then an update is recommended, but not required. Finally, all XC3S50, XC3S1000, XC3S1500, XC3S2000, XC3S4000, and XC3S5000 FPGA applications that use block RAM and have or may have a date code of “0433” or later do require the bitstream update.

**Xilinx recommends updating the bitstream for all Spartan-3 FPGAs** using the Xilinx ISE 6.3i, Service Pack 1 software or later. By updating the bitstream, the application can use any existing or future Spartan-3 FPGA device.
