These errata apply **ONLY** to Spartan-3 XC3S50 FPGAs, including both production devices and engineering samples. These errata **DO NOT** apply to any other Spartan-3 FPGA. If using a different Spartan-3 FPGA, check for errata specific to that device.

Some Power Up Sequences where the VCCINT Supply Powers Up Last May Fail to Configure

Readback Feature Not Available on Devices with “GQ” Fabrication/Process Code Marking Built Before Date Code “0532”

New FACTORY_JF Settings Required for Spartan-3 DCMs

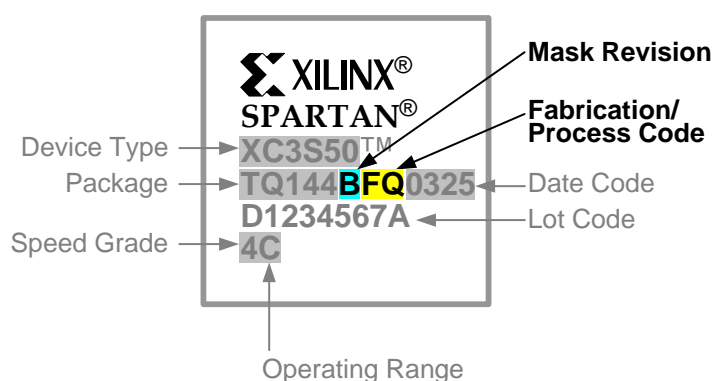
Figure 1: Spartan-3 FPGA from UMC 200 mm facility with “FQ” Fabrication/Process Code Marking

This issue potentially affects some applications where the VCCINT power supply is the last supply to reach its Power-On Reset (POR) voltage threshold. This issue only affects devices with the “FQ” fabrication/process code, as indicated in [Table 4](#).

OPTION 1: Use Spartan-3 FPGAs fabricated from the 300 mm production facility or specially-screened FPGAs from the 200 mm production facility.

If the application requires FPGAs from the 200 mm production facility—which is unlikely for most applications—then specially-screened 200 mm Spartan-3 FPGAs can be ordered by appending “0961” to the standard Xilinx part number.

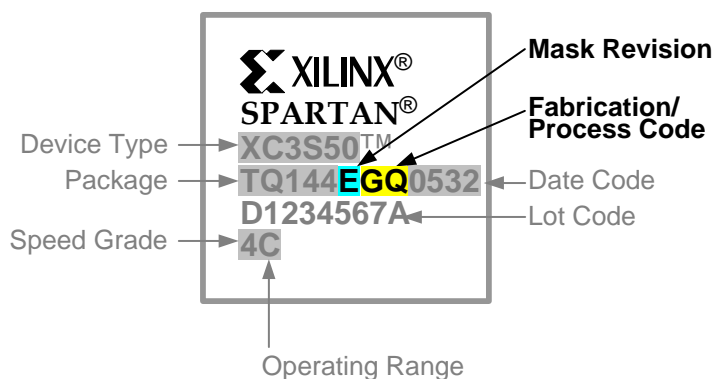
Figure 2: Spartan-3 FPGA from UMC 300 mm facility with “GQ” Fabrication/Process Code Marking

This issue only applies to those designs using the Readback feature on the XC3S50 FPGAs shown in [Table 5](#) with a “BGQ” Fabrication/Process Code marking, as shown in [Figure 2](#).

XC3S50 FPGAs with an “FQ” Fabrication/Process Code marking fully support the Readback feature. Similarly, XC3S50 FPGAs with an “EGQ” Mask/Fabrication/Process Code marking and with a Date Code of “0532” or later fully support Readback.

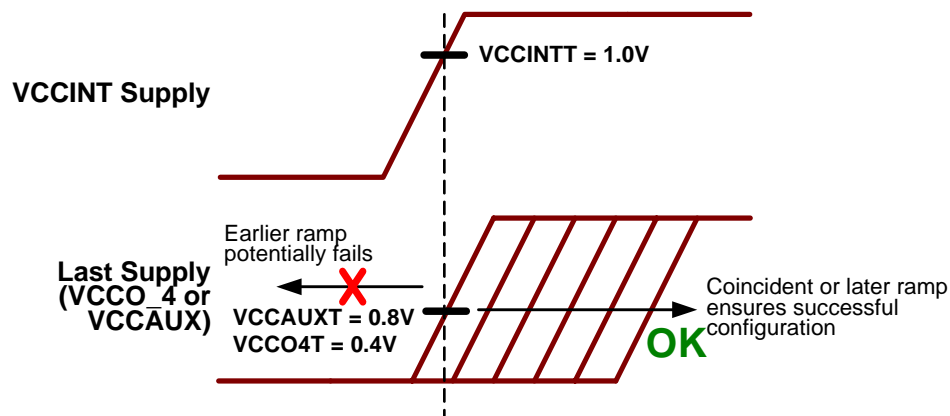
Figure 3: Requirements when VCCINT is not the Last Supply

In the potentially failing condition, the VCCINT supply must be the last supply to reach its valid POR voltage and the ramp rate must be slower than 500 μ S. When the FPGA fails to configure, the INIT_B remains Low and the FPGA ignores the PROG_B program pin. Even with the worst identified power sequence, actual failures only occur on a small percentage of devices, typically measured in parts per million. The issue is more pronounced at cold temperatures.

OPTION 2: Use a power-on sequence where VCCINT is not the last supply to reach its POR threshold level.

VCCINT must reach its maximum POR threshold ($V_{CCINTT} = 1.0V$) before or coincident with VCCAUX reaching its minimum threshold ($V_{CCAUXT} = 0.8V$). This supply sequence and threshold relationship is illustrated in [Figure 3](#).

Alternatively, VCCINT must reach its maximum POR threshold ($V_{CCINTT} = 1.0V$) before or coincident with VCCO_4 supplying I/O bank 4 reaching its minimum threshold ($V_{CCO4T} = 0.4V$). This supply sequence and threshold relationship is also illustrated in [Figure 3](#).

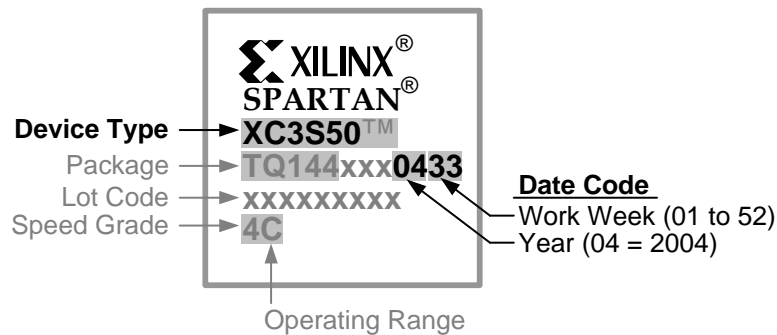
Figure 5: Example Spartan-3 Package Markings

Spartan-3 block RAM internal timing is controlled by settings in the FPGA configuration bitstream. Through yield analysis, new optimal bitstream settings were identified for specific Spartan-3 device types. These new settings improve the block RAM internal timing margin, which consequently improves overall product yield and availability. **These new settings do not affect any timing in the FPGA application**, only internal timing relationships within the block RAM. The specific improved internal block RAM timing path is the relationship between the write-enable timing and the input latch-enable timing.

These new bitstream settings are now the default settings starting with Xilinx ISE 6.3i, Service Package 1, available for download from the Xilinx web site after September 13, 2004. XC3S50 FPGAs are tested using these new bitstream settings beginning with date codes “0433”, corresponding to Work Week 33 of 2004. [Figure 5](#) shows an example top marking for a Spartan-3 FPGA. The relevant fields to identify an affected device are highlighted and include the **Device Type** and the **Date Code**.

Please regenerate any Spartan-3 FPGA configuration bitstreams created using software versions prior to Xilinx ISE 6.3i development software, Service Pack 1. By updating the bitstream, the application can use any existing or future production Spartan-3 FPGA device.
