These errata apply **ONLY** to Spartan[®]-3 XC3S1500 and XC3S1500L FPGAs. These errata **DO NOT** apply to any other Spartan-3 FPGA. If using a different Spartan-3 FPGA, check for errata specific to that device.

Although Xilinx has made every effort to ensure that the XC3S1500/L devices are of the highest possible quality, these devices are subject to the limitations described in the following errata. Please review these errata to ensure that XC3S1500 or XC3S1500L FPGA devices meet your application requirements. Xilinx wants you to know about any known issues that may potentially affect your Spartan-3 FPGA application. This notice also includes [advisories](#) on the latest Spartan-3 FPGA design practices.

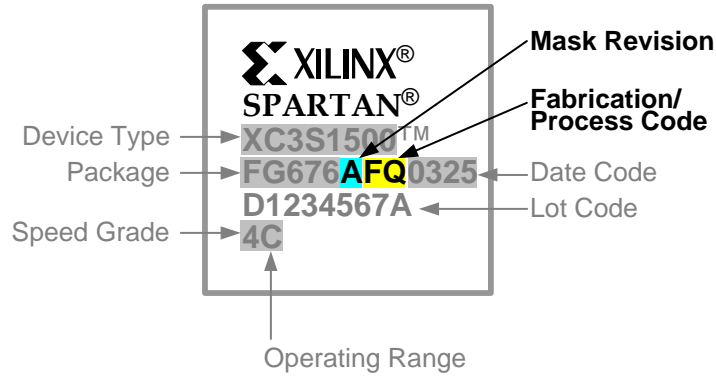
Figure 1: Spartan-3 FPGA from UMC 200 mm facility with “FQ” Fabrication/Process Code Marking

This issue only affects the XC3S1500 FPGAs shown in [Table 4](#), marked with the “AFQ” mask/fab/process code as shown in [Figure 1](#).

This issue only affects the XC3S1500 FPGAs shown in [Table 6](#), marked with the “AFQ” mask/fab/process code as shown in [Figure 1](#).

This issue only affects the XC3S1500 FPGAs shown in [Table 7](#), marked with the "AFQ" mask/fab/process code as shown in [Figure 1](#).

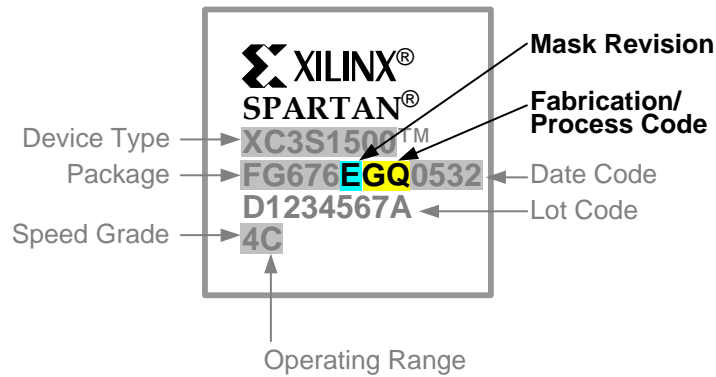
Figure 2: Spartan-3 FPGA from UMC 300 mm facility with “GQ” Fabrication/Process Code Marking

This issue only applies to those designs using the Readback feature on the XC3S1500 or XC3S1500L FPGAs shown in [Table 8](#) with an "AGQ" mask/fab/process code marking, or "EGQ" before date code 0532, as shown in [Figure 2](#).

This issue is corrected on XC3S1500L FPGAs and on XC3S1500 FPGAs with a “BGQ” or “EGQ” mask/fab/process code marking, as shown in [Figure 2](#).

This issue is corrected on XC3S1500L FPGAs and XC3S1500 FPGAs with a “BGQ” or “EGQ” mask/fab/process code marking, as shown in [Figure 2](#).

This issue is corrected on XC3S1500L FPGAs and XC3S1500 FPGAs with a "BGQ" or "EGQ" mask/fab/process code marking, as shown in [Figure 2](#).

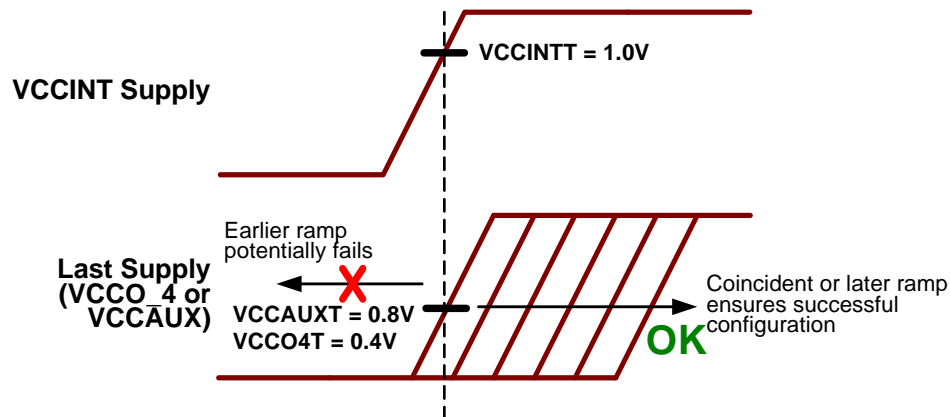
Figure 3: Requirements when VCCINT is not the Last Supply

Three voltage-supply inputs—VCCINT, VCCAUX and the VCCO supply to Bank 4—control the behavior of the Spartan-3 FPGA Power On Reset (POR) circuit. When applying power, a Power-On Reset (POR) circuit within the FPGA monitors each of these three rails. Once the voltages on each of the three rails exceed their respective POR thresholds, the POR circuit allows the FPGA to continue with its configuration process.

In the potentially failing condition, the VCCINT supply must be the last supply to reach its valid POR voltage and the ramp rate must be slower than 500 μ S. When the FPGA fails to configure, the INIT_B remains Low and the FPGA ignores the PROG_B program pin. Even with the worst identified power sequence, actual failures only occur on a small percentage of devices, typically measured in parts per million. The issue is more pronounced at cold temperatures.

OPTION 2: Use a power-on sequence where VCCINT is not the last supply to reach its POR threshold level.

VCCINT must reach its maximum POR threshold ($V_{CCINTT} = 1.0V$) before or coincident with VCCAUX reaching its minimum threshold ($V_{CCAUXT} = 0.8V$). This supply sequence and threshold relationship is illustrated in [Figure 3](#).

Alternatively, VCCINT must reach its maximum POR threshold ($V_{CCINTT} = 1.0V$) before or coincident with VCCO_4 supplying I/O bank 4 reaching its minimum threshold ($V_{CCO4T} = 0.4V$). This supply sequence and threshold relationship is also illustrated in [Figure 3](#).

The lowest power-consuming sequence is to apply VCCAUX before or coincident with VCCINT, then VCCINT followed by VCCO_4. If VCCINT is applied before VCCAUX, the VCCINT supply consumes a surplus current until the VCCAUX supply reaches its maximum POR threshold, VCCAUXT. This additional current is a few hundred to several hundred milliamps (mA). This additional current is not required for successful configuration and the surplus current disappears when VCCAUX is applied.

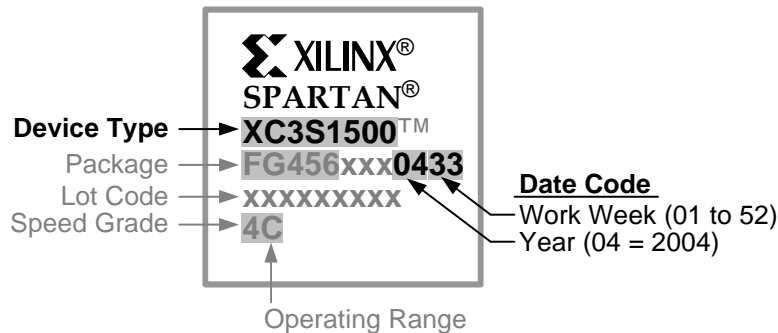
Figure 5: Example Spartan-3 Device Package Markings

Spartan-3 FPGA block RAM internal timing is controlled by settings in the FPGA configuration bitstream. Through yield analysis, new optimal bitstream settings were identified for specific Spartan-3 device types. These new settings improve the block RAM internal timing margin, which consequently improves overall product yield and availability. **These new settings do not affect any timing in the FPGA application**, only internal timing relationships within the block RAM. The specific improved internal block RAM timing path is the relationship between the write-enable timing and the input latch-enable timing.

These new bitstream settings are now the default settings starting with Xilinx ISE 6.3i, Service Package 1, available for download from the Xilinx web site after September 13, 2004. XC3S1500 FPGAs are tested using these new bitstream settings beginning with date codes “0433”, corresponding to Work Week 33 of 2004. [Figure 5](#) shows an example top marking for a Spartan-3 FPGA. The relevant fields to identify an affected device are highlighted and include the **Device Type** and the **Date Code**.

Please regenerate any Spartan-3 FPGA configuration bitstreams created using software versions prior to Xilinx ISE 6.3i development software, Service Pack 1. By updating the bitstream, the application can use any existing or future production Spartan-3 FPGA device.

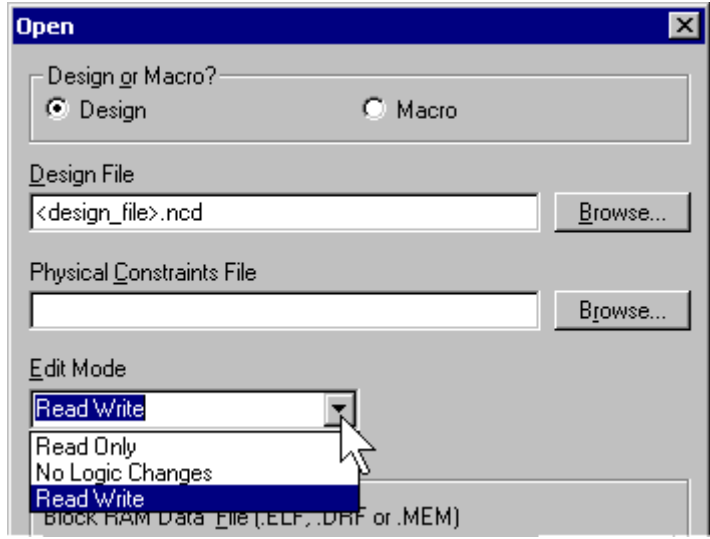
Figure 6: Enable User Editing in FPGA Editor

The DCM automatically compensates for process, voltage, and temperature (PVT) changes and consequently it periodically updates its delay tap settings. The rate at which the update occurs is controlled by an internal attribute called FACTORY_JF. Xilinx has identified an optimal FACTORY_JF setting value (FACTORY_JF=8080). Other settings may potentially fail to track properly over process, voltage, and temperature.

Without using the optimal settings, the DCM could potentially, with low probability, fail to assert the LOCKED output, could lose lock, or could produce erroneous clock outputs.

If the design is complete, with no further edits planned, then FPGA Editor offers the easiest method to update the FACTORY_JF setting.

- Invoke the FPGA Editor. On Windows PCs, select **Start → Xilinx ISE 6 → Accessories → FPGA Editor**.
- Select **File → Open**. Select the *.ncd file for the completed design. Set the **Edit Mode** to "Read Write" mode as shown in [Figure 6](#).
