These errata apply **ONLY** to Spartan-3 XC3S2000 FPGAs, including both production devices and engineering samples. These errata **DO NOT** apply to any other Spartan-3 FPGA. If using a different Spartan-3 FPGA, check for errata specific to that device.

Readback Feature Not Available on Devices Built Before Date Code “0532”

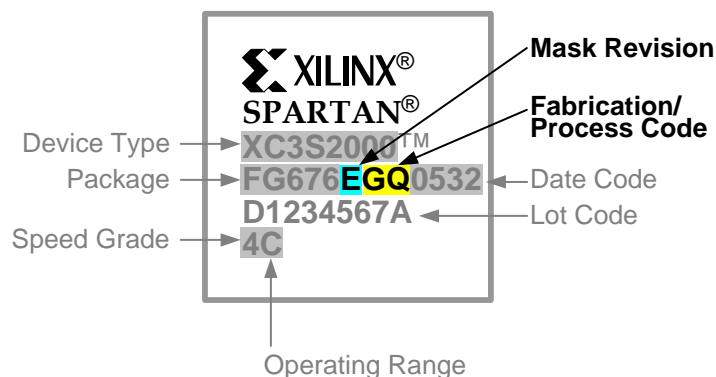
Figure 1: Spartan-3 FPGA from UMC 300 mm facility with “GQ” Fabrication/Process Code Marking

This issue only applies to those designs using the Readback feature on the XC3S2000 FPGAs shown in [Table 4](#) with either a “BGQ” Fabrication/Process Code marking or a date code prior to “0532”, as shown in [Figure 1](#).

Device Types:	XC3S2000
Mask Revision Codes:	B (any date code) and E with date codes prior to “0532”
Fabrication/Process Codes:	GQ only
Packages:	All
Speed Grades:	All
Date Codes:	All

The readback feature is not available for the devices indicated in [Table 4](#).

XC3S2000 FPGAs with an “EGQ” Mask/Fabrication/Process Code marking and with a Date Code of “0532” or later fully support Readback. XC3S2000 FPGAs ordered using the standard part number (i.e., no SCD codes) scheduled for delivery after 15-AUG-2005 automatically include the latest mask revision and Readback functionality.

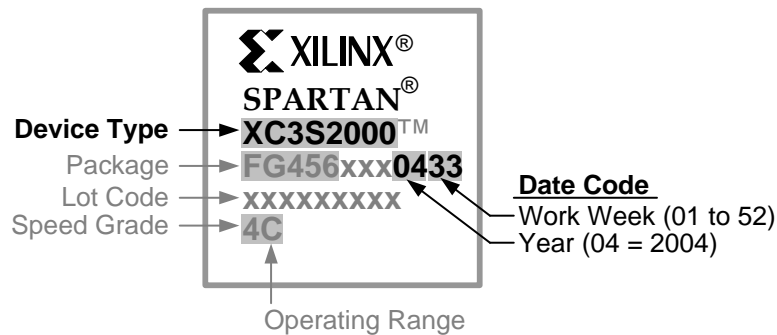
Figure 2: Example Spartan-3 Package Markings

These new bitstream settings are now the default settings starting with Xilinx ISE 6.3i, Service Package 1, available for download from the Xilinx web site after September 13, 2004. XC3S2000 FPGAs are tested using these new bitstream settings beginning with date codes “0433”, corresponding to Work Week 33 of 2004. [Figure 2](#) shows an example top marking for a Spartan-3 FPGA. The relevant fields to identify an affected device are highlighted and include the Device Type and the Date Code.

Please regenerate any Spartan-3 FPGA configuration bitstreams created using software versions prior to Xilinx ISE 6.3i development software, Service Pack 1. By updating the bitstream, the application can use any existing or future production Spartan-3 FPGA device.

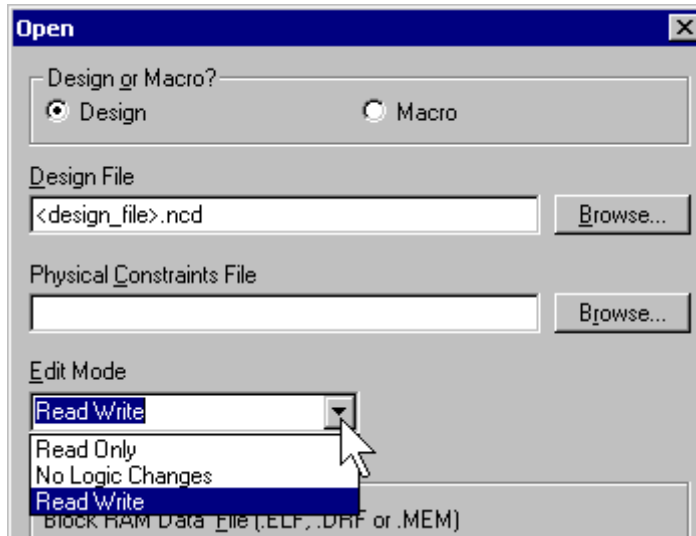
Figure 3: Enable User Editing in FPGA Editor

The DCM automatically compensates for process, voltage, and temperature (PVT) changes and consequently it periodically updates its delay tap settings. The rate at which the update occurs is controlled by an internal attribute called FACTORY_JF. Xilinx has identified an optimal FACTORY_JF setting value (FACTORY_JF=8080). Other settings may potentially fail to track properly over process, voltage, and temperature.

Without using the optimal settings, the DCM could potentially, with low probability, fail to assert the LOCKED output, could lose lock, or could produce erroneous clock outputs.

- Invoke the FPGA Editor. On Windows PCs, select **Start** → **Xilinx ISE 6** → **Accessories** → **FPGA Editor**.
- Select **File** → **Open**. Select the *.ncd file for the completed design. Set the **Edit Mode** to "Read Write" mode as shown in [Figure 3](#).
