These errata apply **ONLY** to Spartan-3 XC3S5000 FPGAs, including both production devices and engineering samples. These errata **DO NOT** apply to any other Spartan-3 FPGA. If using a different Spartan-3 FPGA, check for errata specific to that device.

### Readback Feature Not Available on Devices Built Before Date Code “0532”

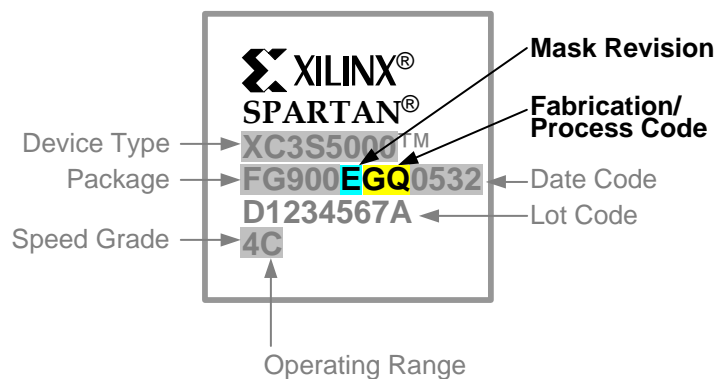
Figure 1: Spartan-3 FPGA from UMC 300 mm facility with “GQ” Fabrication/Process Code Marking

This issue only applies to those designs using the Readback feature on the XC3S5000 FPGAs shown in [Table 4](#) with a “AGQ” Fabrication/Process Code marking or a date code prior to “0532”, as shown in [Figure 1](#).

The readback feature is not available for the devices indicated in [Table 4](#).

XC3S5000 FPGAs with an “EGQ” Mask/Fabrication/Process Code marking and with a Date Code of “0532” or later fully support Readback. XC3S5000 FPGAs ordered using the standard part number (without SCD codes) scheduled for delivery after 15-AUG-2005 automatically include the latest mask revision and Readback functionality.

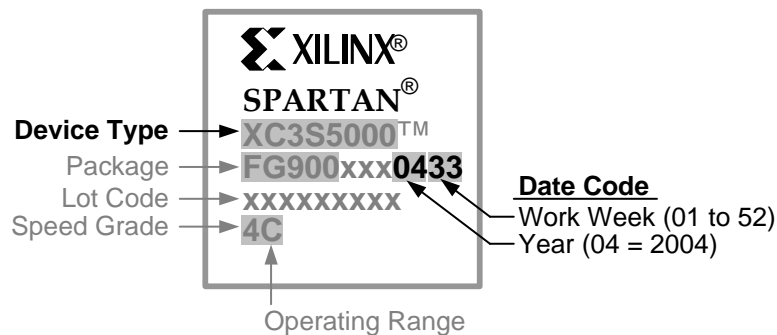
Figure 2: Example Spartan-3 Package Markings

Spartan-3 block RAM internal timing is controlled by settings in the FPGA configuration bitstream. Through yield analysis, new optimal bitstream settings were identified for specific Spartan-3 device types. These new settings improve the block RAM internal timing margin, which consequently improves overall product yield and availability. **These new settings do not affect any timing in the FPGA application**, only internal timing relationships within the block RAM. The specific improved internal block RAM timing path is the relationship between the write-enable timing and the input latch-enable timing.

These new bitstream settings are now the default settings starting with Xilinx 6.3i, Service Package 1, available for download from the Xilinx web site after September 13, 2004. XC3S5000 FPGAs are tested using these new bitstream settings beginning with date codes “0433”, corresponding to Work Week 33 of 2004. [Figure 2](#) shows an example top marking for a Spartan-3 FPGA. The relevant fields to identify an affected device are highlighted and include the **Device Type** and the **Date Code**.

**Please regenerate any Spartan-3 FPGA configuration bitstreams** created using software versions prior to Xilinx ISE 6.3i development software, Service Pack 1. By updating the bitstream, the application can use any existing or future production Spartan-3 FPGA device.

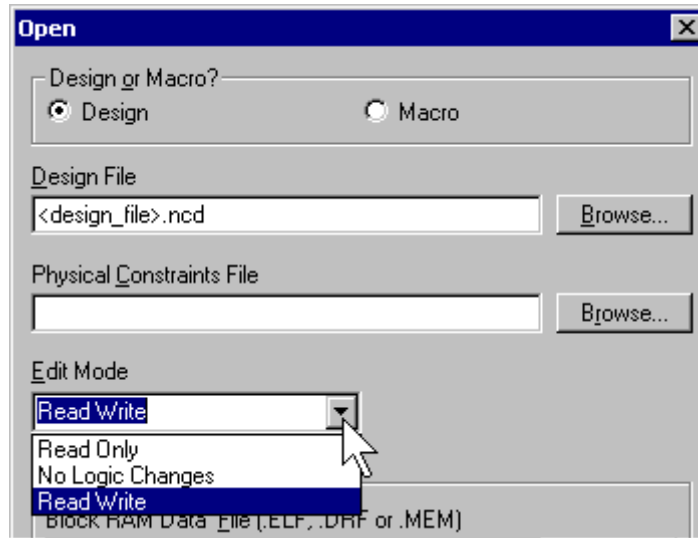
Figure 3: Enable User Editing in FPGA Editor

The DCM automatically compensates for process, voltage, and temperature (PVT) changes and consequently it periodically updates its delay tap settings. The rate at which the update occurs is controlled by an internal attribute called FACTORY\_JF. Xilinx has identified an optimal FACTORY\_JF setting value (FACTORY\_JF=8080). Other settings may potentially fail to track properly over process, voltage, and temperature.

Without using the optimal settings, the DCM could potentially, with low probability, fail to assert the LOCKED output, could lose lock, or could produce erroneous clock outputs.

- Invoke the FPGA Editor. On Windows PCs, select **Start** → **Xilinx ISE 6** → **Accessories** → **FPGA Editor**.
- Select **File** → **Open**. Select the \*.ncd file for the completed design. Set the **Edit Mode** to "Read Write" mode as shown in [Figure 3](#).
