## Introduction

Thank you for your interest in the Xilinx XC3S700A FPGA device engineering samples. Although Xilinx has made every effort to ensure the highest possible quality, these devices are subject to the limitations described in this errata notification.

## Device Identification

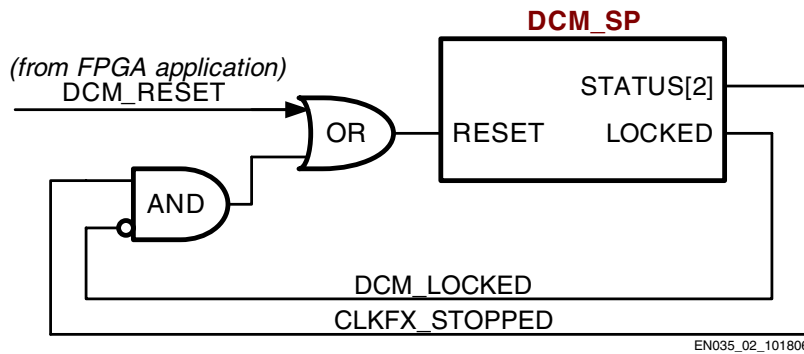
Figure 2: DCM DFS Lock Failure Workaround

This issue potentially affects only those applications that use the Digital Frequency Synthesizer (DFS)—which is part of the Digital Clock Manager (DCM).

A small number of DCM DFS locking failures have been observed during characterization.

A software workaround exists, as shown in [Figure 2](#). This circuit is automatically inserted by the ISE development software starting with version 9.1i. Using FPGA logic, the circuit monitors both the LOCKED output from the DCM\_SP function and the STATUS[2] bit, which indicates that the DFS output CLKFX has stopped. If LOCKED = 0 and STATUS[2] = 1, then the circuit asserts the DCM RESET input. If the FPGA application also resets the DCM, then OR the reset signal from the FPGA application with the monitored output signals.
