Introduction

Thank you for participating in the Xilinx Virtex™-4 Engineering Sample Program. As part of this program, we are pleased to provide to you engineering samples of the Virtex-4 XC4VLX40 FPGA. Although Xilinx has made every effort to ensure the highest possible quality, these devices are subject to the limitations described in the following errata.

Table 1: XC4VLX40 FPGA Devices Affected by These Errata

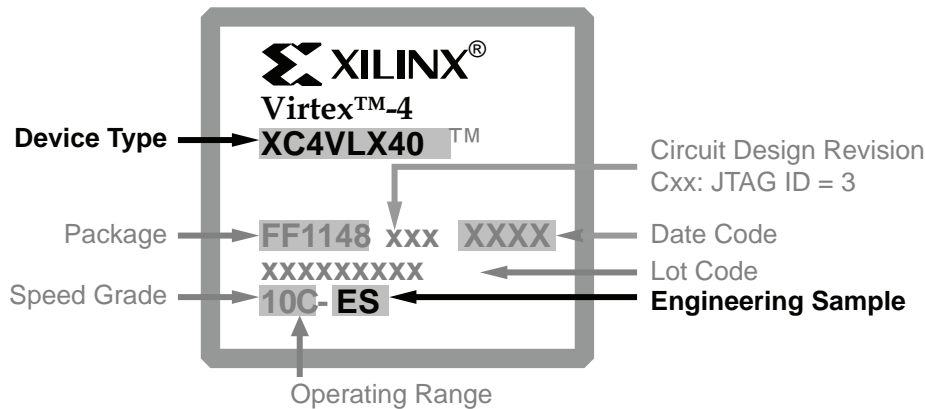
Figure 1: Example XC4VLX40CES Package Marking

The XC4VLX40 is marked as shown in Figure 1.
