## Introduction

Thank you for participating in the Xilinx Virtex™-4 Engineering Sample Program. As part of this program, we are pleased to provide to you engineering samples of the Virtex-4 XC4VLX15 FPGA. Although Xilinx has made every effort to ensure the highest possible quality, these devices are subject to the limitations described in the following errata.

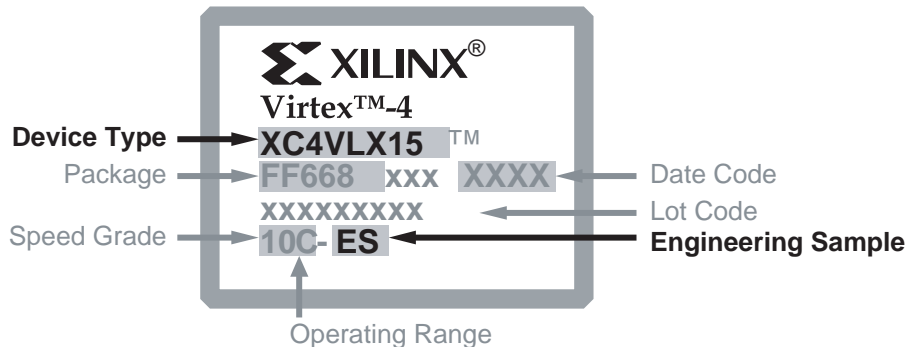
Figure 1: Example XC4VLX15CES Package Marking

The XC4VLX15 is marked as shown in Figure 1.
