## Introduction

Xilinx has made every effort to ensure the highest possible quality. These Virtex®-5 FPGA engineering samples (ES) adhere to the specifications described in the following errata.

These errata apply to the Virtex-5 devices shown in [Table 1](#).

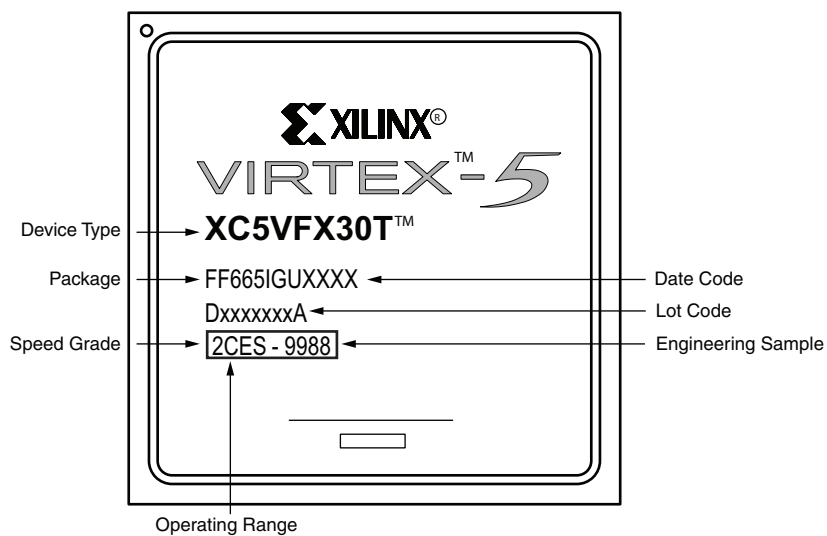
Figure 1: Example XC5VFX30T CES9988 Package Marking

The XC5VFX30T CES9988 is marked as shown in [Figure 1](#). The other devices listed in [Table 1](#) are marked similarly.
