Introduction

Thank you for designing with the Xilinx Virtex®-6 family of devices. Although Xilinx has made every effort to ensure the highest possible quality, the devices listed in [Table 1](#) are subject to the limitations described in the following errata.

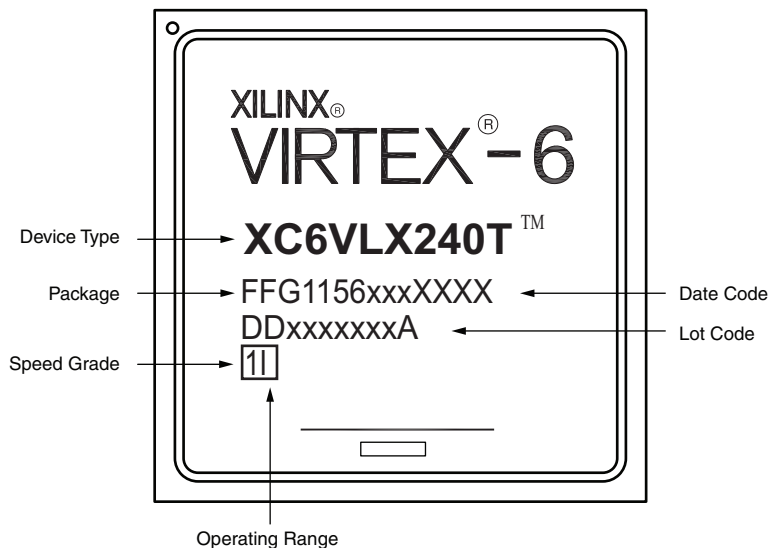
Figure 1: XC6VLX240T-1FFG1156I Marking

The XC6VLX240T is marked as shown in [Figure 1](#). The other devices listed in [Table 1](#) are marked similarly.
