## Introduction

Thank you for designing with the Xilinx Virtex®-6 family of devices. Although Xilinx has made every effort to ensure the highest possible quality, the devices listed in [Table 1](#) are subject to the limitations described in the following errata.

*Table 1: Device Affected by These Errata*

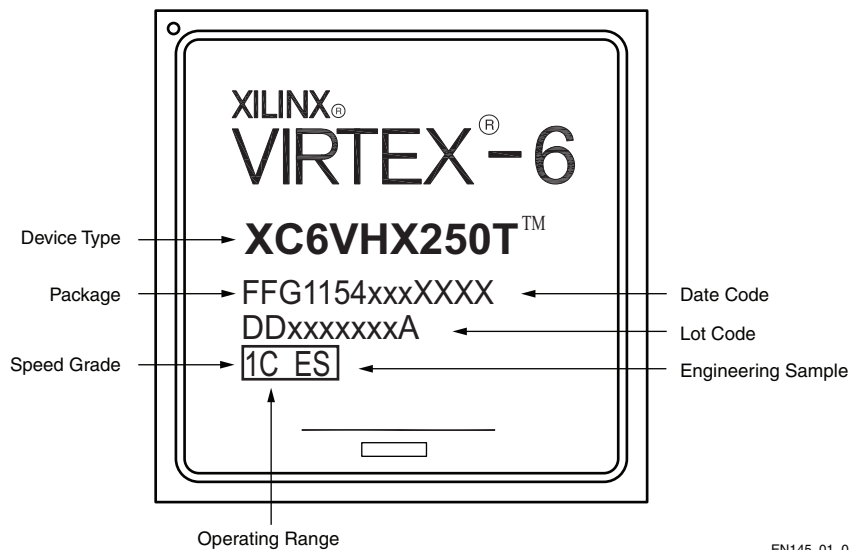
EN145\_01\_042310

Figure 1: Example Device Top Mark

The XC6VHX250T is marked as shown in [Figure 1](#). The other devices listed in [Table 1](#) are marked similarly.
