Introduction

Thank you for participating in the Virtex®-6 FPGA Engineering Sample Program. As part of this program, we are pleased to provide to you engineering samples of the devices listed in [Table 1](#). Although Xilinx has made every effort to ensure the highest possible quality, these devices are subject to the limitations described in the following errata.

Hardware Errata Details

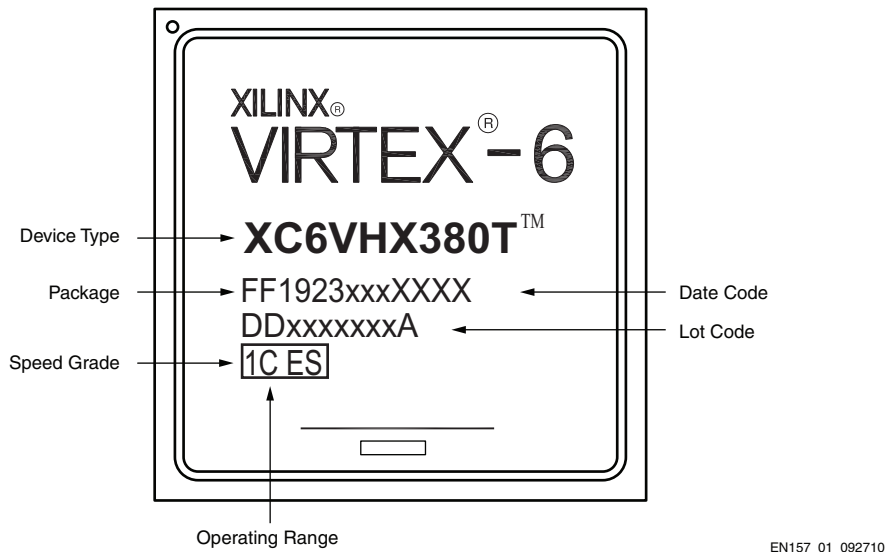
Figure 1: Example Device Top Mark

The XC6VHX380T is marked as shown in [Figure 1](#).
