## Introduction

Thank you for designing with the Xilinx Defense-Grade Zynq®-7000Q family of devices. Although Xilinx has made every effort to ensure the highest possible quality, the devices listed in [Table 1](#) are subject to the limitations described in the following errata.

## Processor System (PS) Errata Details

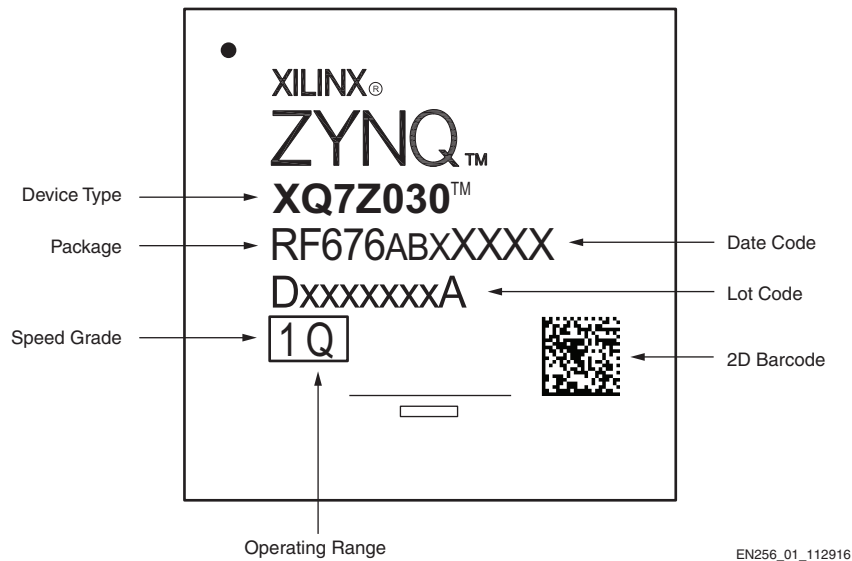
Figure 1: Example Device Top Mark

Figure 1 shows an example device top mark for the device listed in Table 1. Refer to [XCN16014](#) for details on the addition of the 2D barcode.

Date	Version	Description of Revisions
12/16/2016	1.5	Updated <a href="#">Figure 1</a> with 2D barcode.
10/19/2015	1.4	Added <a href="#">Under Very Rare Timing Circumstances, Transition Into Streaming Mode Might Create A Data Corruption</a> and <a href="#">When ECC Is Enabled, The CHE_CORR_ECC_ADDR_REG_OFFSET Register Might Report An Incorrect Column Address</a> .
07/13/2015	1.3	Added XQ7Z100 device to <a href="#">Table 1</a> .
03/16/2015	1.2	Added <a href="#">I2C Slave Monitor Mode Can Lock The I2C Bus</a> and <a href="#">I2C Transaction Corruption In Slave Receiver Mode</a> .
10/31/2014	1.1	Added I2C and QSPI sections. In SMC section, added: <a href="#">SMC Parallel (SRAM/NOR) Interface Does Not Correctly Assert CS0 For 64 MB Memories</a> ; <a href="#">SMC Parallel (SRAM/NOR) Interface Address Bit 25 Is Inverted For 64 MB Memories</a> ; and <a href="#">RxFIFO Not Empty Status Is Not Updated Promptly</a> .
