## Introduction

Thank you for designing with the Xilinx XA Zynq®-7000 Automotive family of devices. Although Xilinx has made every effort to ensure the highest possible quality, the devices listed in [Table 1](#) are subject to the limitations described in the following errata.

## Processor System (PS) Errata Details

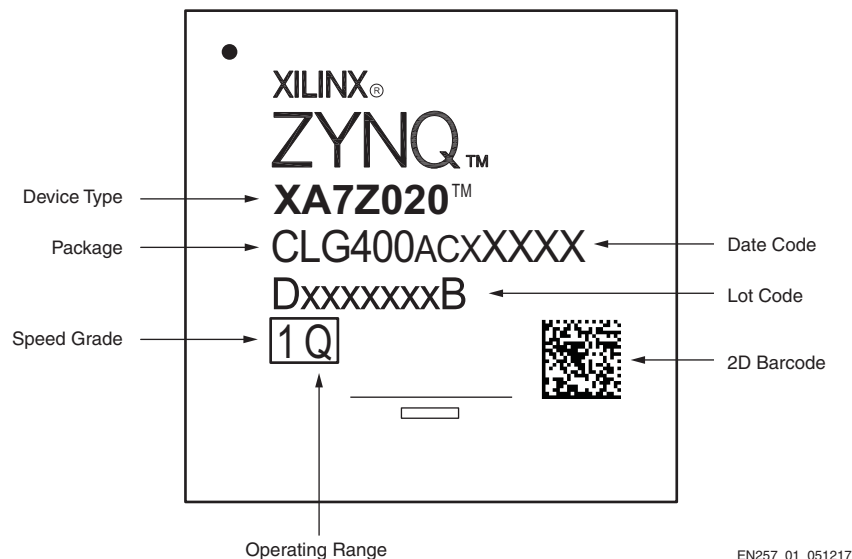
Figure 1: Example Device Top Mark

Figure 1 shows an example device top mark for the device listed in Table 1. Refer to [XCN16014](#) for details on the addition of the 2D barcode.

Date	Version	Description of Revisions
09/11/2017	1.5	Updated <a href="#">Traceability</a> and <a href="#">Figure 1</a> with 2D barcode information.
10/19/2015	1.4	Added <a href="#">Under Very Rare Timing Circumstances, Transition Into Streaming Mode Might Create A Data Corruption</a> and <a href="#">When ECC Is Enabled, The CHE_CORR_ECC_ADDR_REG_OFFSET Register Might Report An Incorrect Column Address</a> .
03/16/2015	1.3	Added <a href="#">I2C Master Generates Invalid Read Transactions</a> and <a href="#">I2C Transaction Corruption In Slave Receiver Mode</a> .
10/01/2014	1.2	Added <a href="#">Glitch Filter In I2C Fast Mode Not Implemented</a> .
08/28/2014	1.1	Added XC7Z030 to <a href="#">Table 1</a> . Added the I2C section: <a href="#">I2C Master Generates Invalid Read Transactions</a> ; <a href="#">Missing I2C Master Completion Interrupt</a> ; <a href="#">I2C Violates t<sub>HD,STA</sub> Requirement For Standard-Mode When It Runs Faster Than 90 kHz</a> ; <a href="#">I2C Violates t<sub>LOW</sub> Requirement For Fast-Mode When It Runs Faster Than 384 kHz</a> ; <a href="#">I2C Violates t<sub>BUF</sub> Requirement For Fast-Mode When It Runs Faster Than 384 kHz</a> ; and <a href="#">I2C Missing Arbitration On Repeated Start</a> . Added the QSPI section: <a href="#">QSPI RxFIFO Not Empty Status Is Not Updated Promptly</a> ; and <a href="#">QSPI Controller Reports Wrong "Busy Status" Of Flash Memories In Dual Parallel Configuration When Auto CS And "Divide by 2" Baud Rate Is Used</a> . Added SDIO section: <a href="#">ADMA2 Burst Transactions Alignment And Length Requirements</a> ; <a href="#">Software Reset Sequence For SDIO Can Hang The Interconnect</a> ; <a href="#">Second CMD12 Can Be Issued If Auto CMD12 Is Enabled</a> ; <a href="#">ADMA2 Mode Fails To Release Properly When Abort CMD Is Issued</a> ; <a href="#">Transfer Complete Asserts Before Completing Busy Due To CMD13</a> ; and <a href="#">CMD13 Not Handled Properly When CMD19 Is In Progress</a> . Also added: <a href="#">SMC Parallel (SRAM/NOR) Interface Does Not Correctly Assert CS0 For 64 MB Memories</a> ; <a href="#">SMC Parallel (SRAM/NOR) Interface Address Bit 25 Is Inverted For 64 MB Memories</a> . Added the SPI section: <a href="#">RxFIFO Not Empty Status Is Not Updated Promptly</a> .
