## Introduction

Thank you for designing with the Zynq® UltraScale+™ MPSoC family. Although Xilinx has made every effort to ensure the highest possible quality, the devices listed in [Table 1](#) are subject to the limitations described in the following errata.

*Table 1: Devices Affected by These Errata*

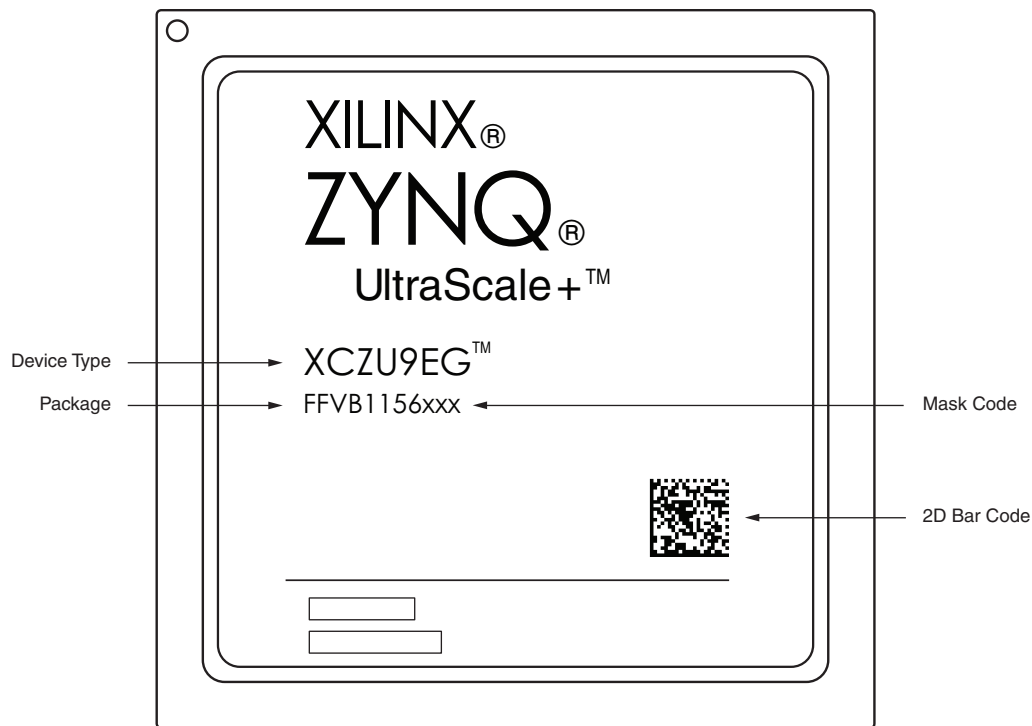
Figure 1: Example Device Top Mark

[Figure 1](#) shows an example device top mark for the devices listed in [Table 1](#).
